**AMETEK U.S.
GAUGE DIVISION**
SELLERSVILLE

**DEEP AQUIFER (SOUTH)
GROUNDWATER
ANALYTICAL RESULTS
VOC AND 1,4-DIOXANE
2013 TO 2014**

**DEEP AQUIFER (NORTH)
GROUNDWATER
ANALYTICAL RESULTS
VOC AND 1,4-DIOXANE
2013 TO 2014**

Drawing Title
**DEEP AQUIFER (SOUTH)
GROUNDWATER
CONTOURS
APRIL 2014**

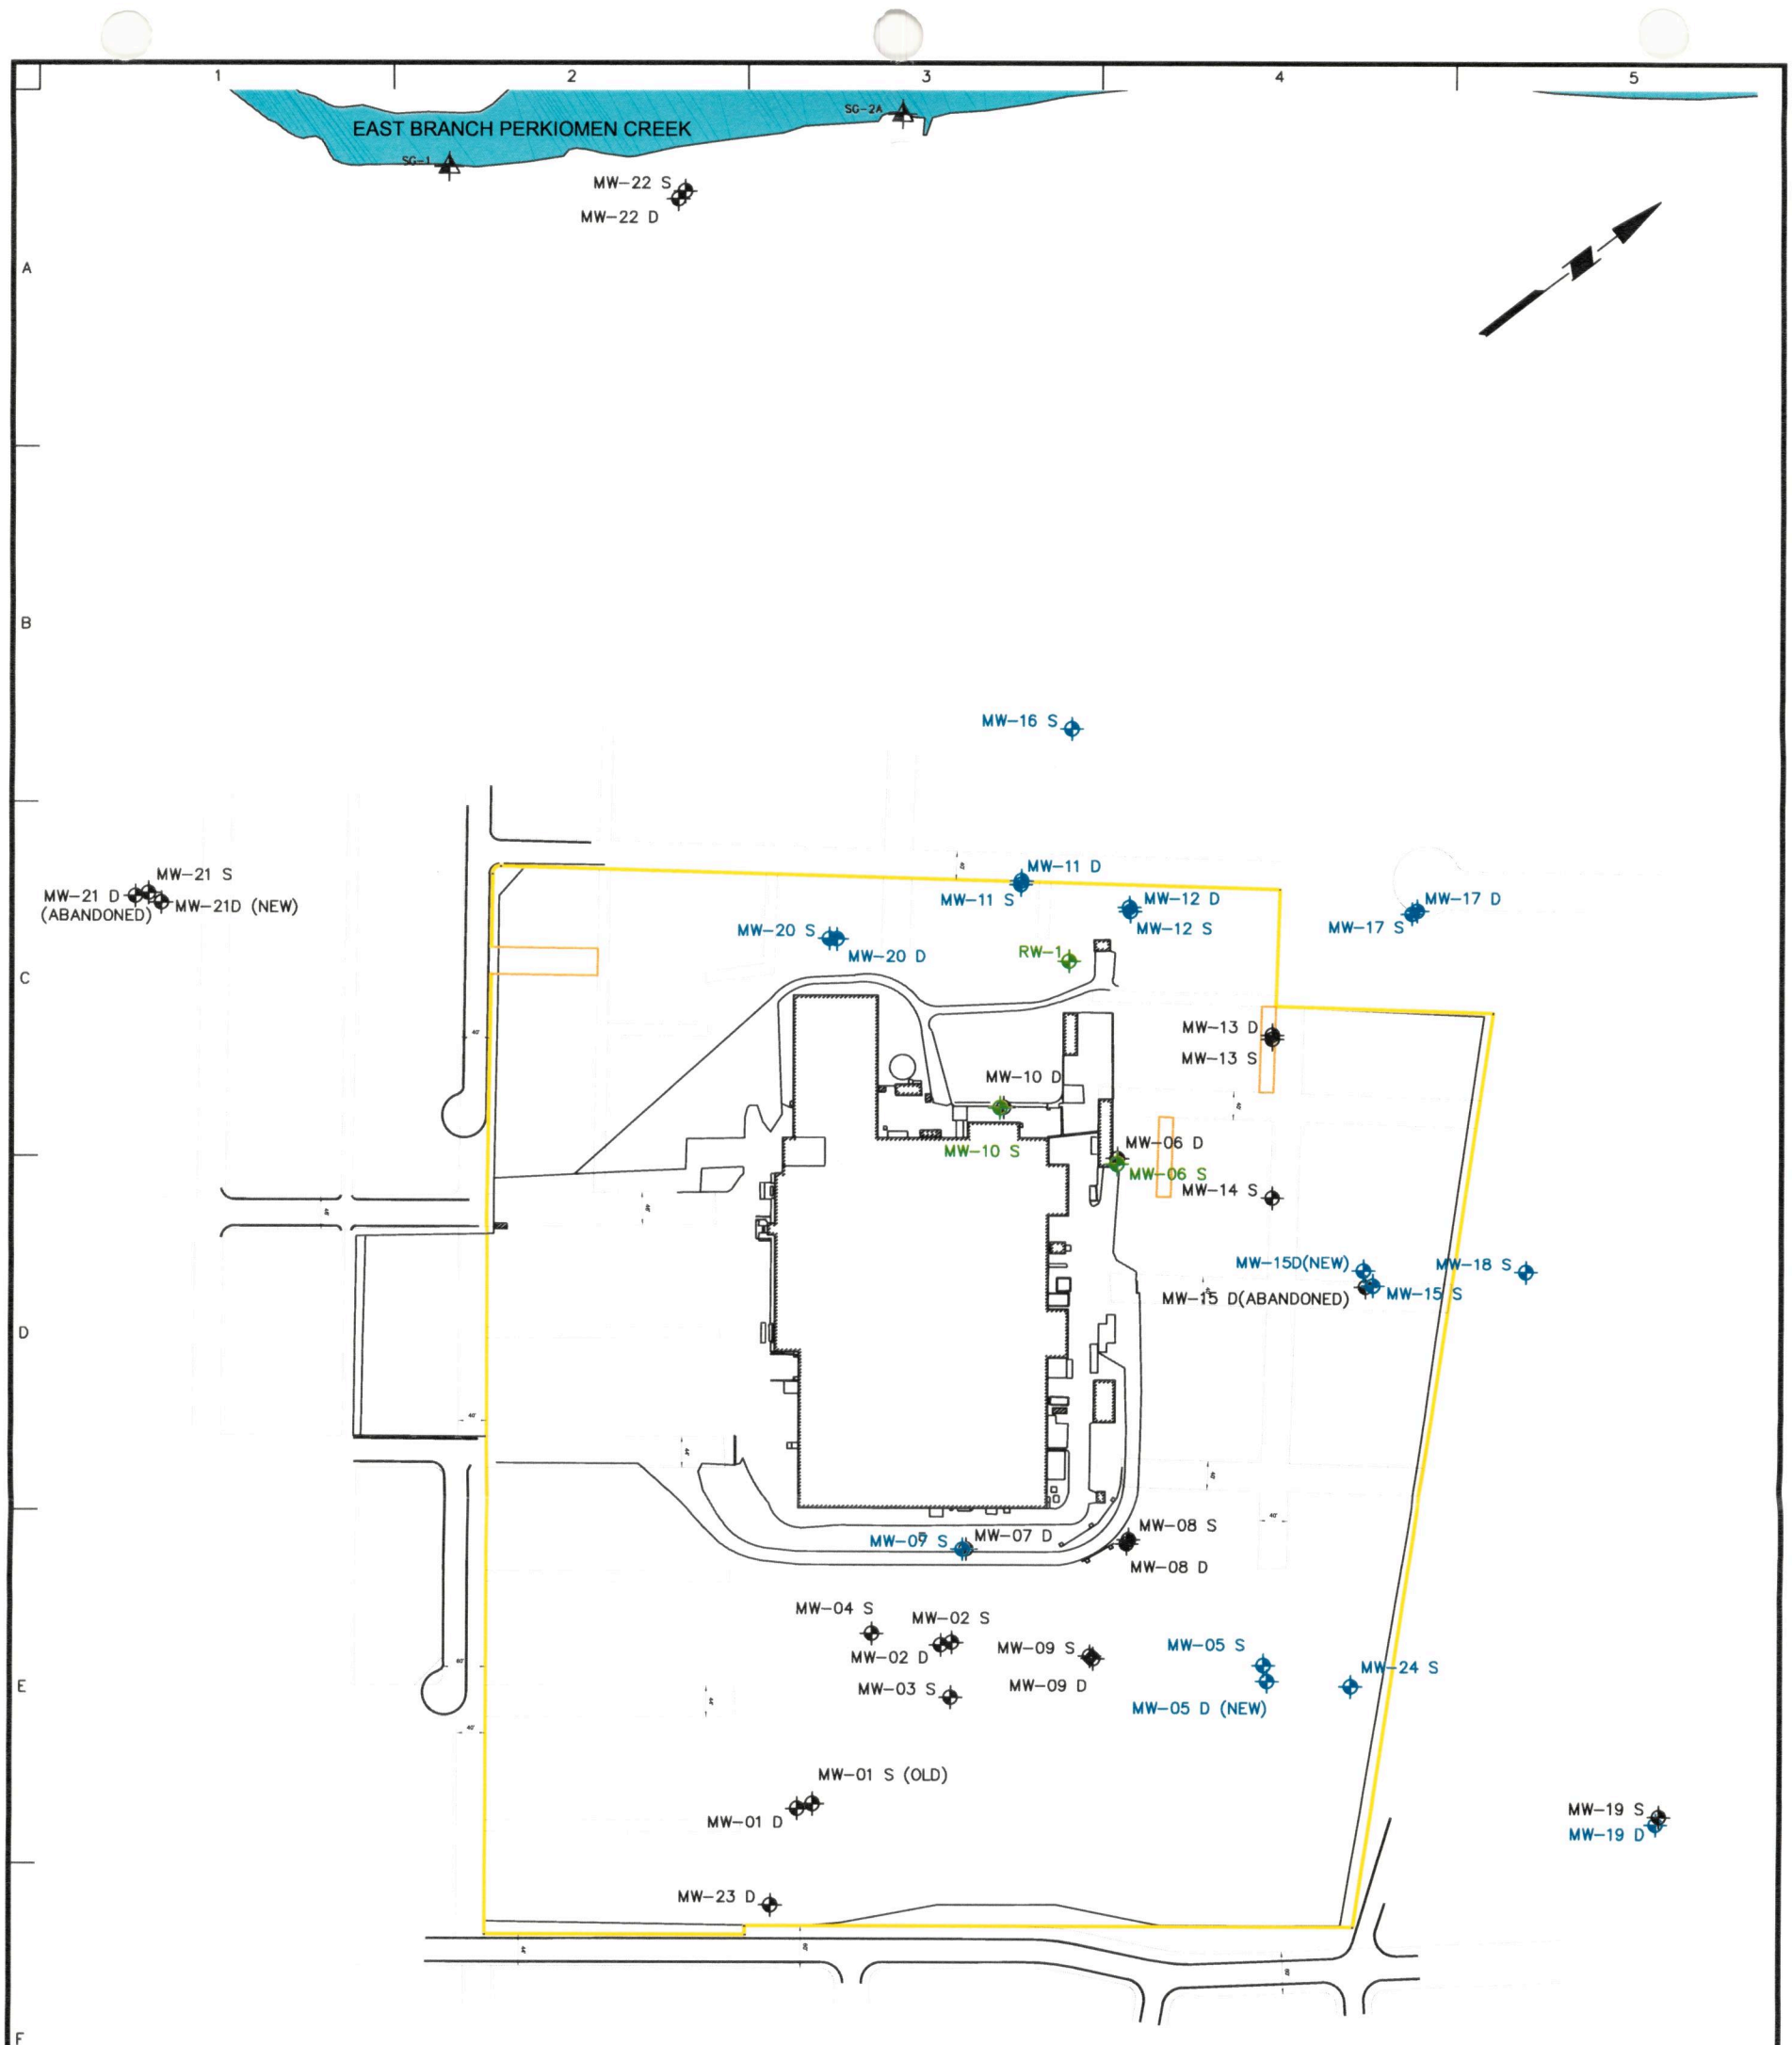
- TI BOUNDARY
- PROPERTY NOT OWNED BY AMETEK
- MW-1 MONITORING WELLS THAT COMPRISE THE TI BOUNDARY MONITORING WELL NETWORK.
- MW-23D SITE MONITORING WELL LOCATION
- RW-1 IRM PUMPING WELL LOCATION

- Notes:
- 1) NEW SITE WIDE BASEMAP SURVEY WAS SURVEYED BY TAYLOR WISEMAN & TAYLOR ON NOVEMBER 2011.
 - 2) TI MONITORING WELLS DISPLATED IN BLUE COMPRISE THE TI BOUNDARY MONITORING WELL NETWORK. MW-21S AND MW-21D (NEW) LIE BEYOND THE TI BOUNDARY, HOWEVER, THEY WILL BE MONITORED UNTIL MCLs ARE OBTAINED. IN ADDITION, MW-22D WILL BE MONITORED FOR 1,4-DIOXANE (PER REVISED WORK PLAN).
 - 3) THE MAIN BUILDING AND OUT STRUCTURES WERE DEMOLISHED IN 2012.

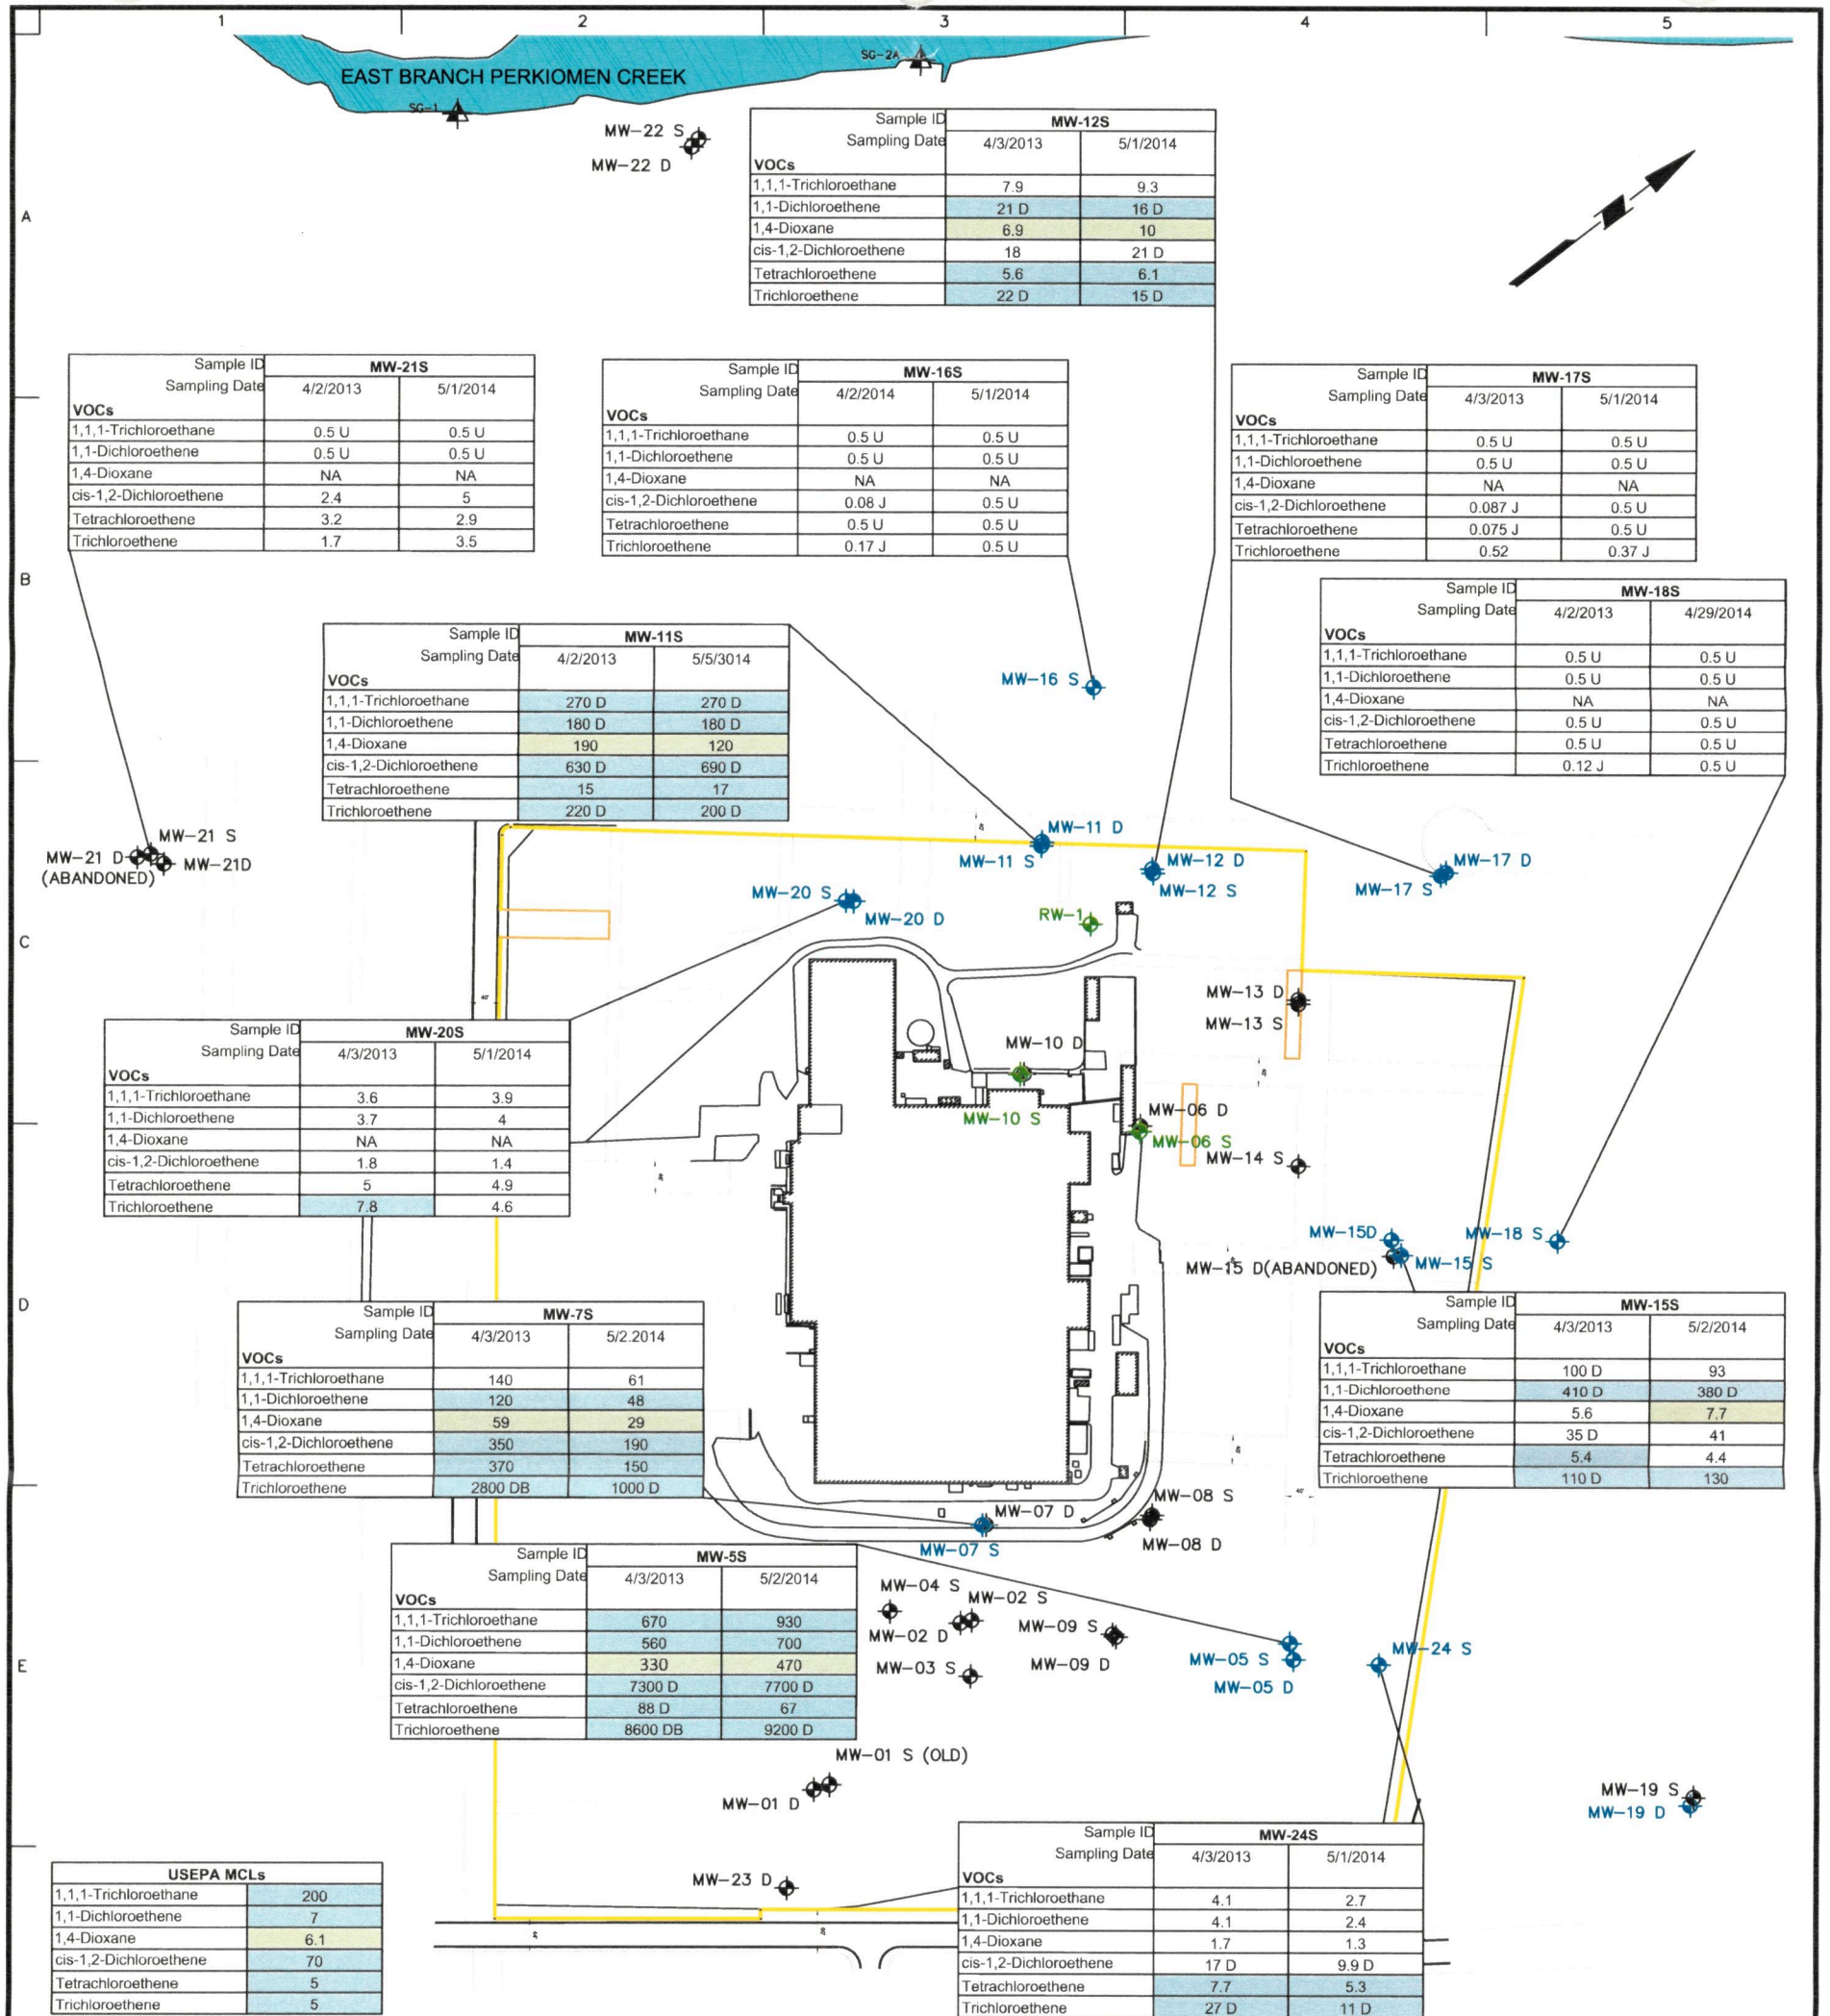
- GROUNDWATER CONSTITUENTS THAT EXCEEDED USEPA'S MAXIMUM CONTAMINANT LEVELS ARE HIGHLIGHTED IN BLUE. 1,4-DIOXANE LEVELS THAT EXCEED THE USEPA'S TAPWATER RISK-BASED SCREENING LEVELS OF 6.1µg/L ARE HIGHLIGHTED IN GREEN.

- NA = NOT ANALYZED (WELLS ANALYZED PER REVISED WORK PLAN).
- ALL CONCENTRATIONS ARE IN MICROGRAMS/LITER (µg/L).
- THE MW-6D (FORMER GROUNDWATER RECOVERY WELL) GROUNDWATER RECOVERY PUMP HAS BEEN DISCONNECTED, NO SAMPLE CAN BE COLLECTED.

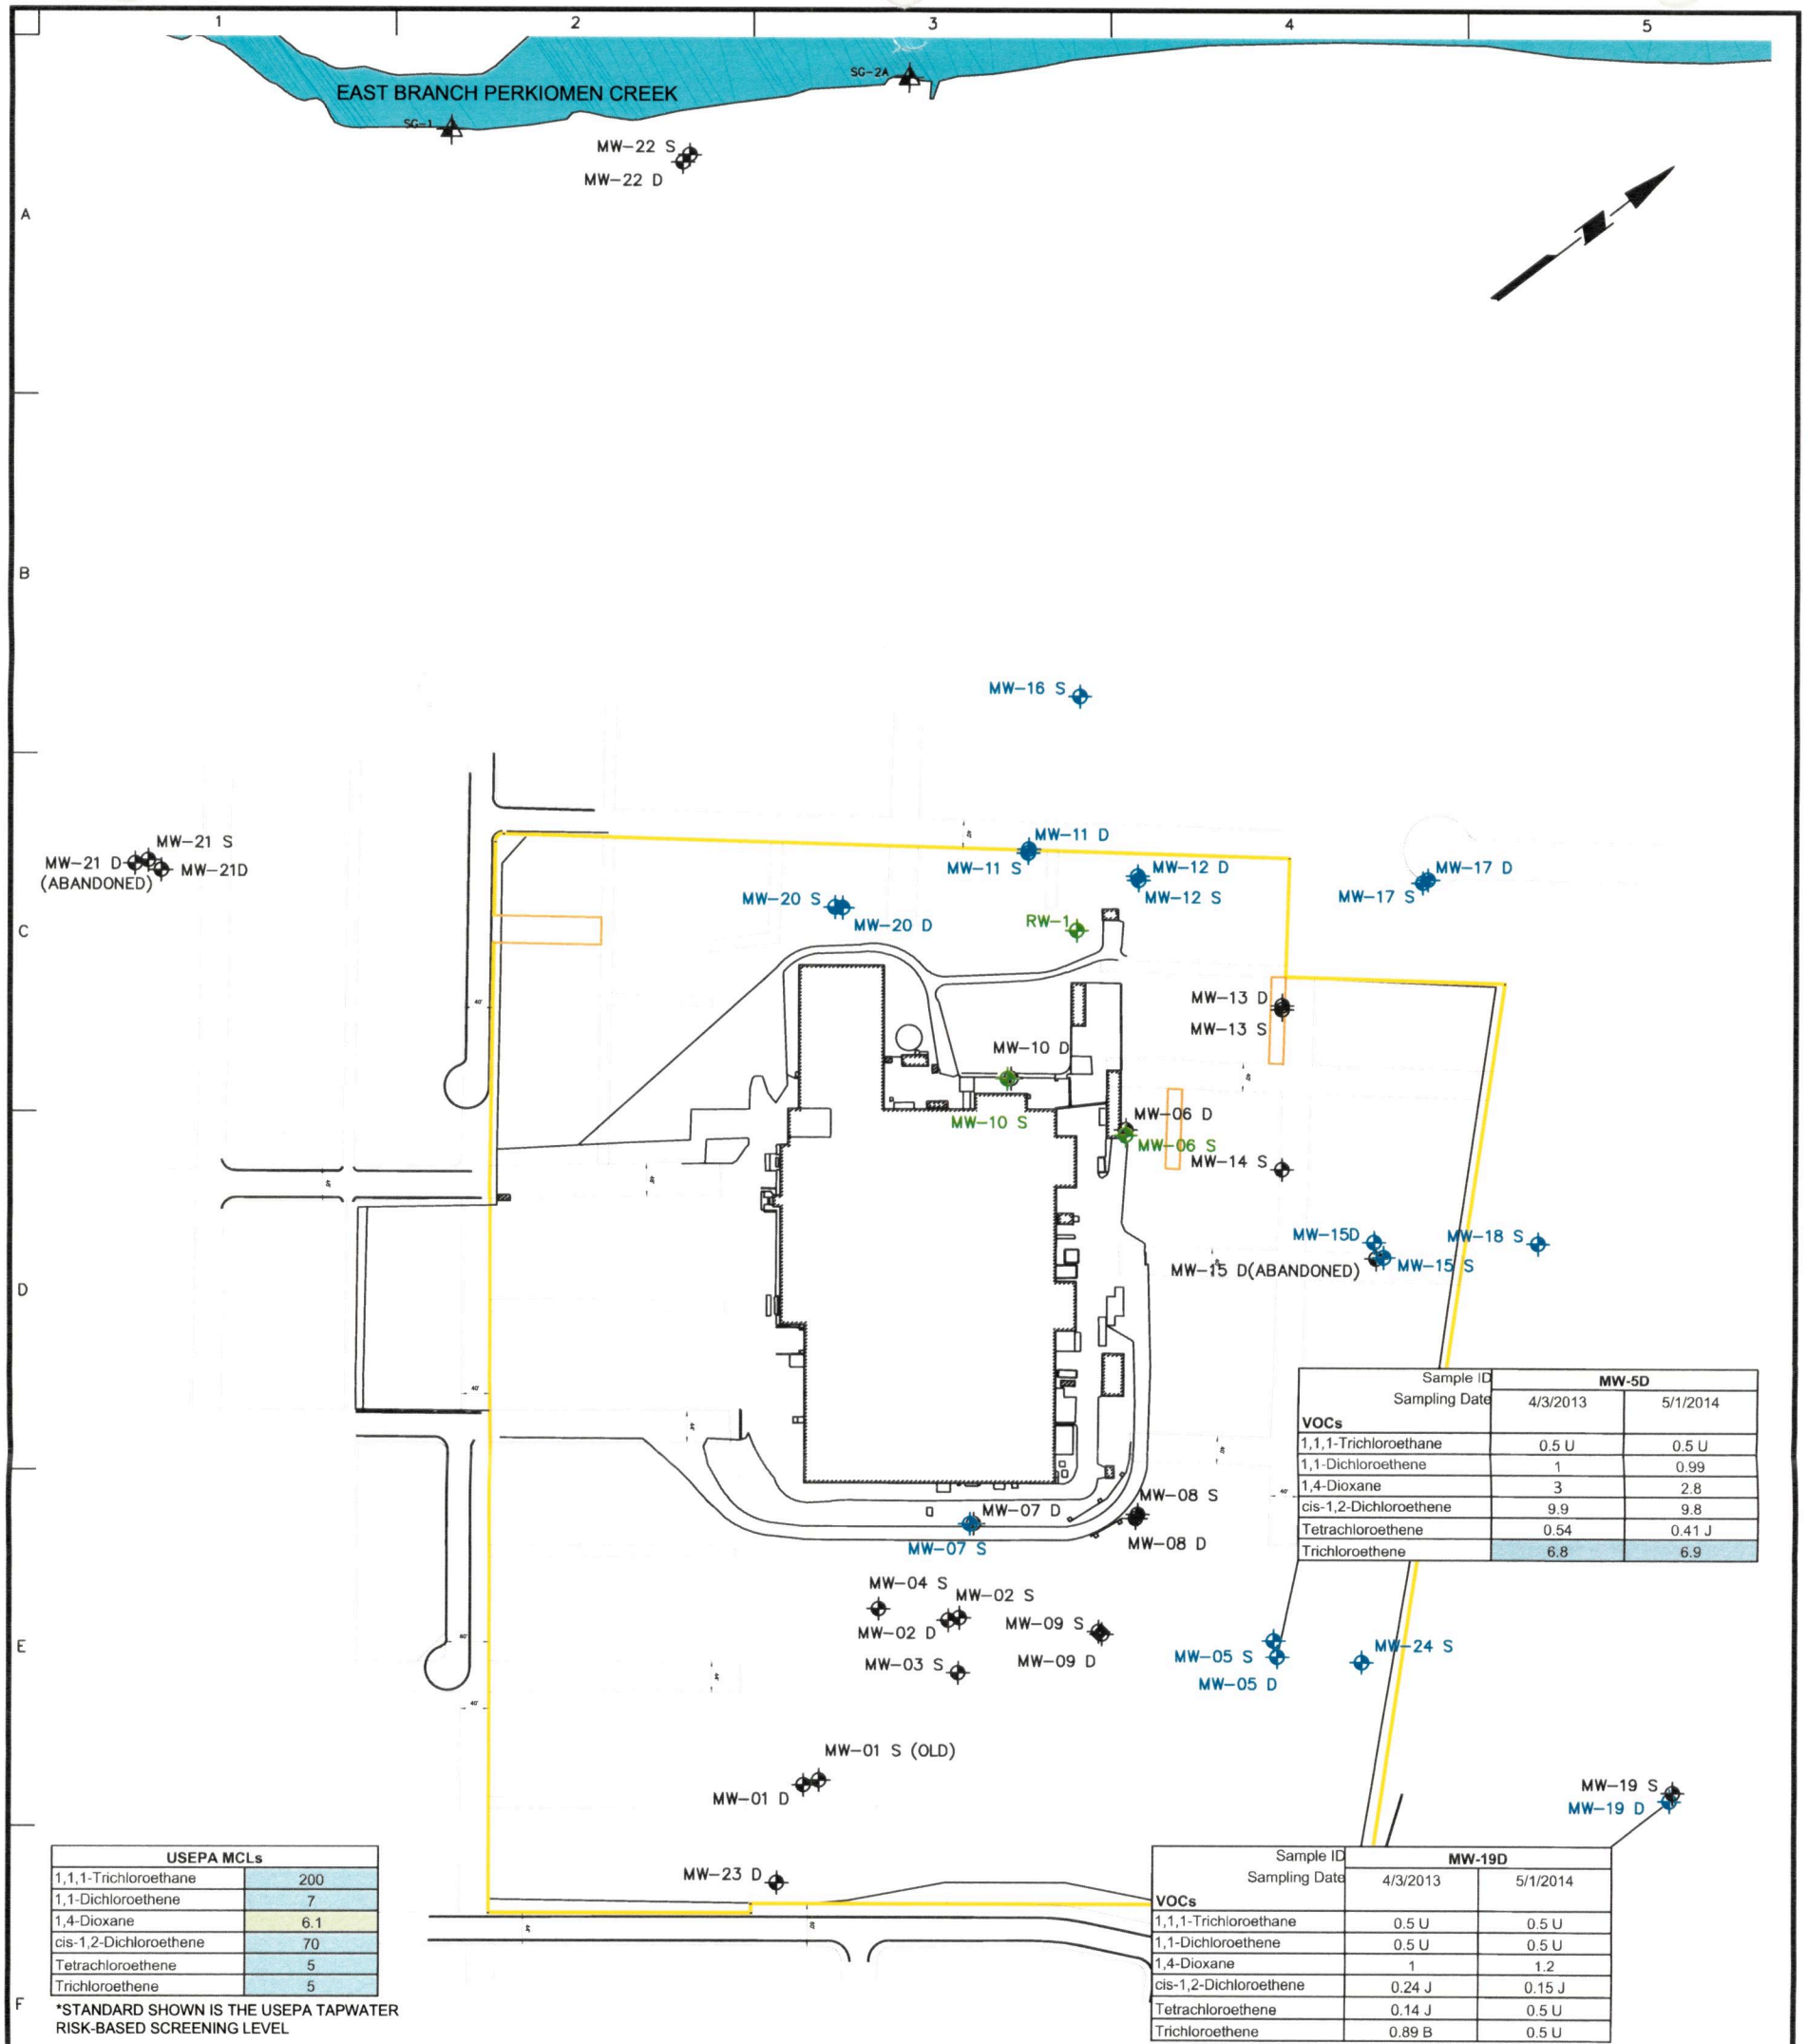
- U = THE COMPOUND WAS ANALYZED FOR, BUT WAS NOT DETECTED
- D = THE REPORTED VALUE IS TAKEN FROM THE ANALYSIS OF A DILUTED SAMPLE.
- J = THE COMPOUND WAS POSITIVELY IDENTIFIED; THE ASSOCIATED NUMERICAL VALUE IS THE APPROXIMATE CONCENTRATION OF THE ANALYTE IN THE SAMPLE.
- B = THE COMPOUND WAS FOUND IN THE BLANK AND SAMPLE.

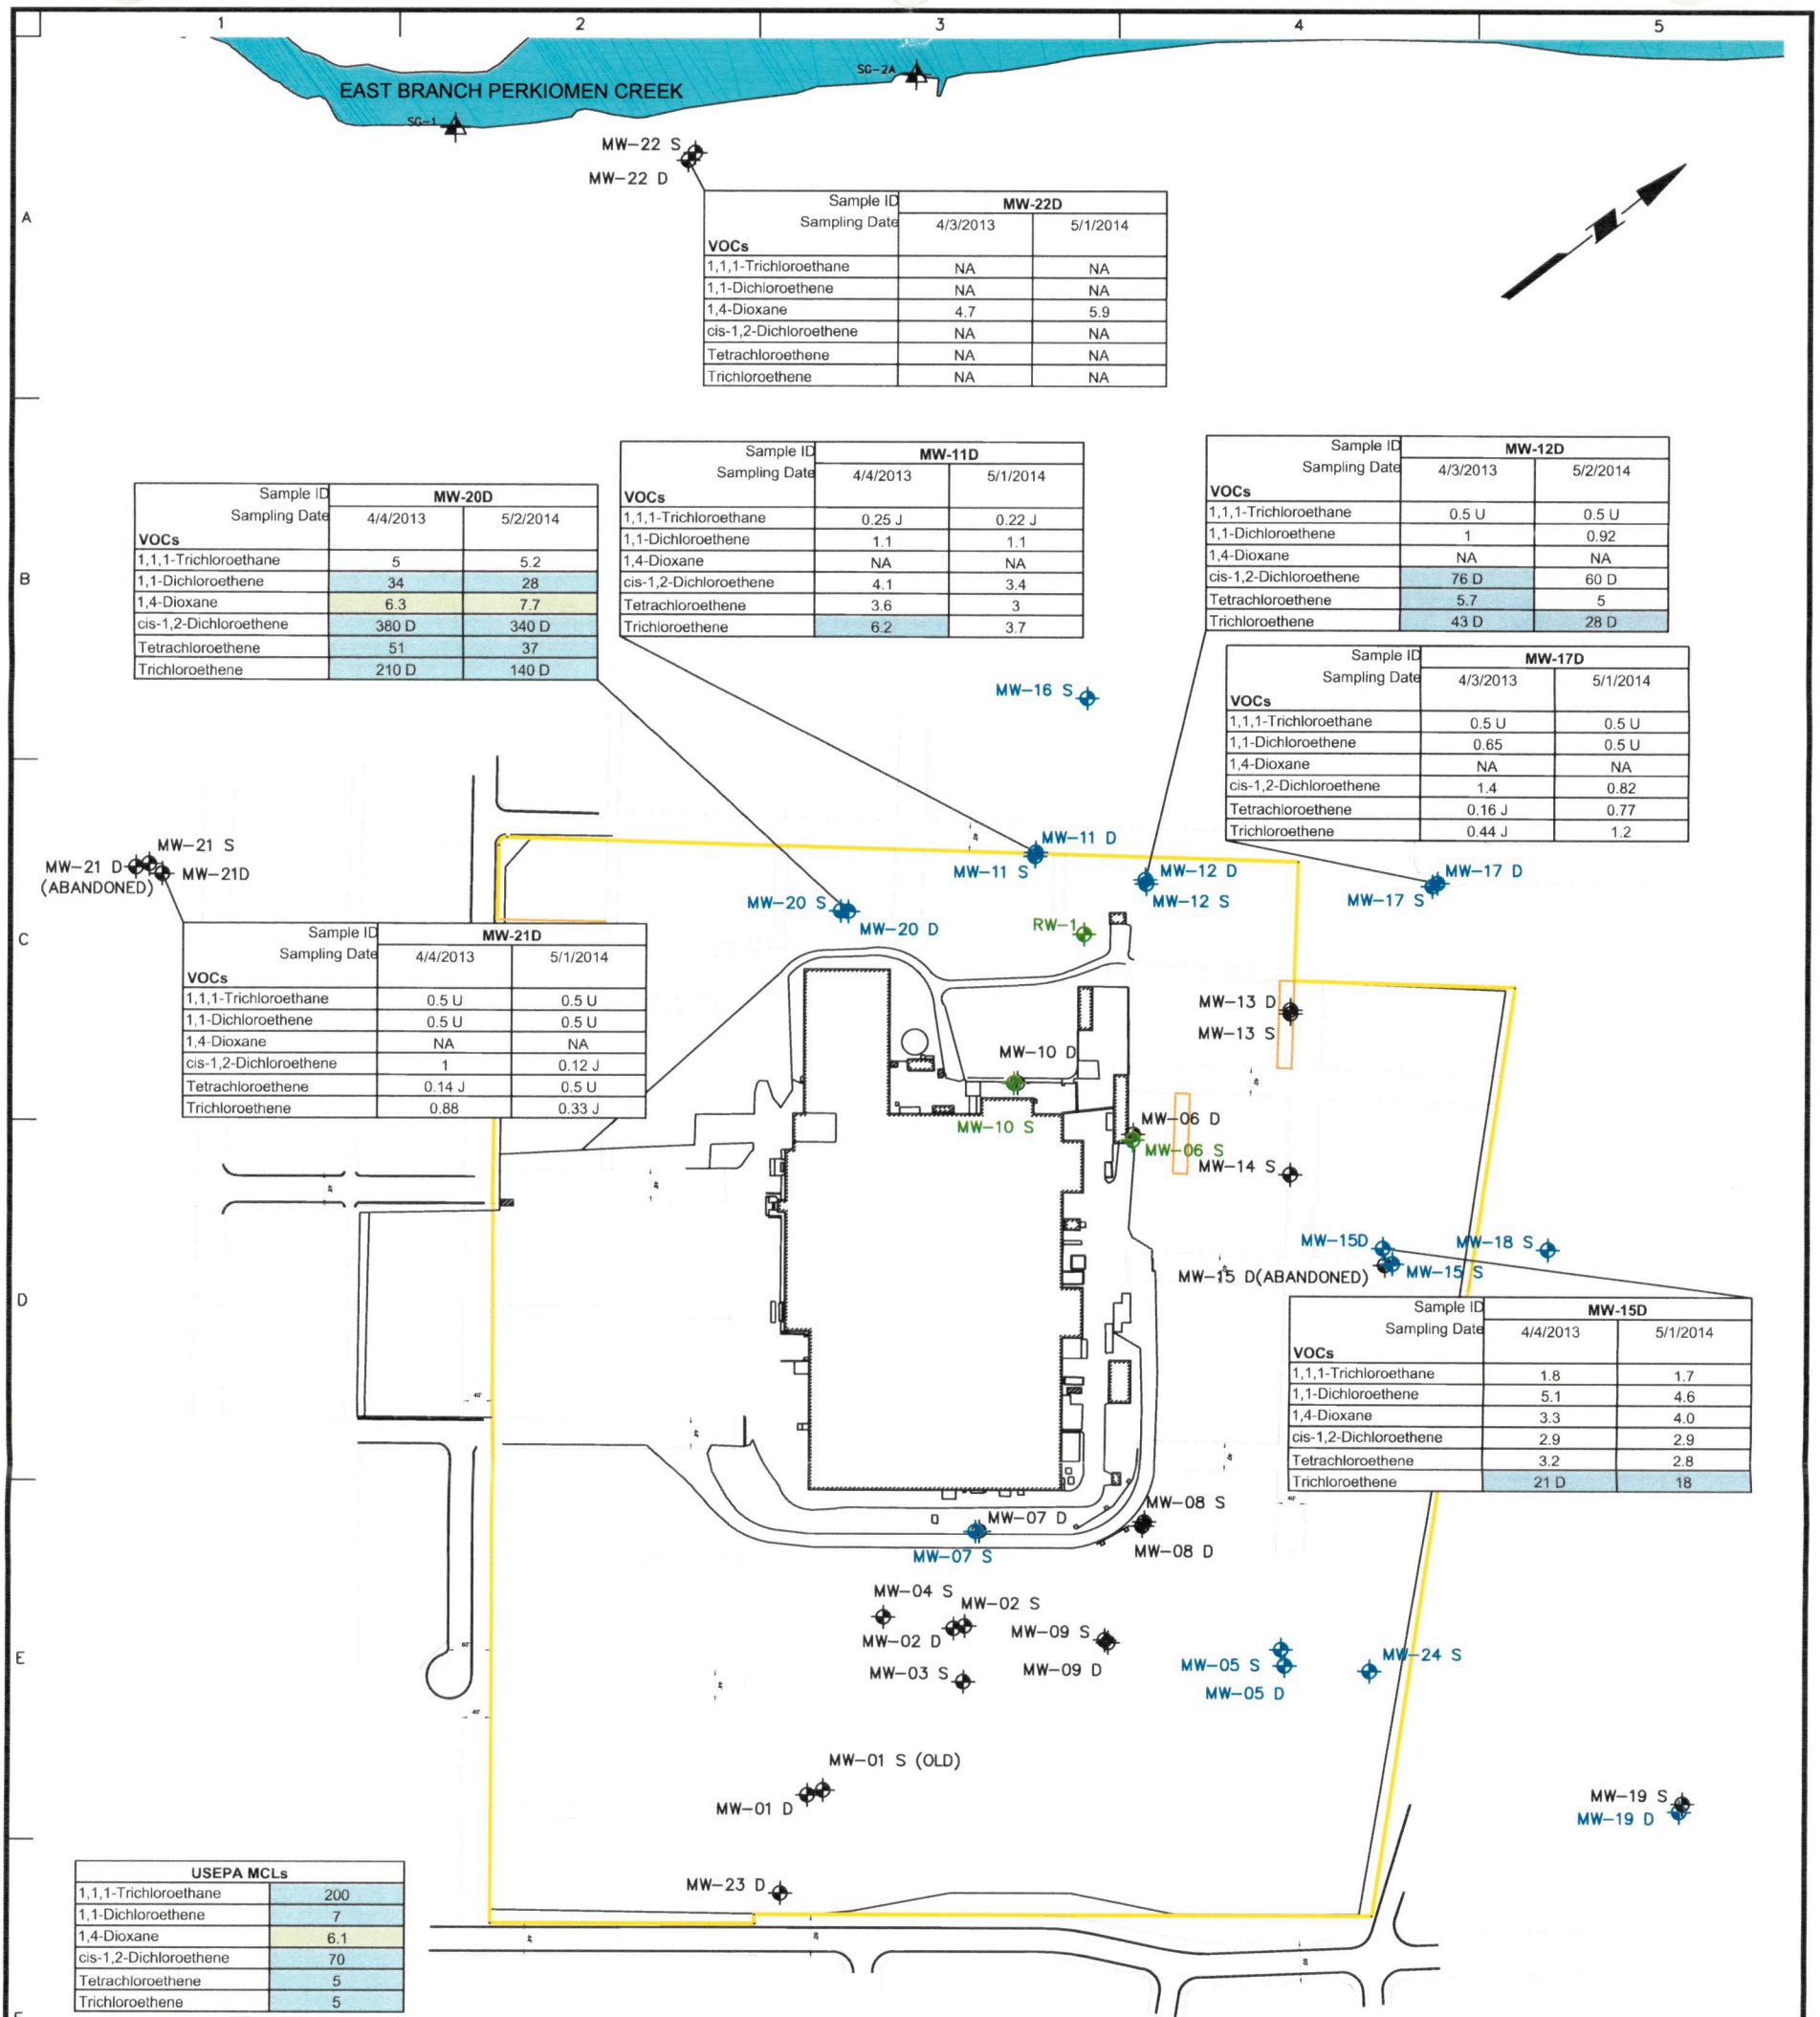
- 1) GROUNDWATER CONSTITUENTS THAT EXCEEDED USEPA'S MAXIMUM CONTAMINANT LEVELS ARE HIGHLIGHTED IN BLUE. 1,4-DIOXANE LEVELS THAT EXCEED THE USEPA'S TAPWATER RISK-BASED SCREENING LEVELS OF 6.1µg/L ARE HIGHLIGHTED IN GREEN.

- 4) NA = NOT ANALYZED (WELLS ANALYZED PER CMI MONITORING PROGRAM)
- 5) ALL CONCENTRATIONS ARE IN MICROGRAMS/LITER (µg/L).
- 6) THE MW-6D (FORMER GROUNDWATER RECOVERY WELL) GROUNDWATER RECOVERY PUMP HAS BEEN DISCONNECTED, NO SAMPLE CAN BE COLLECTED.

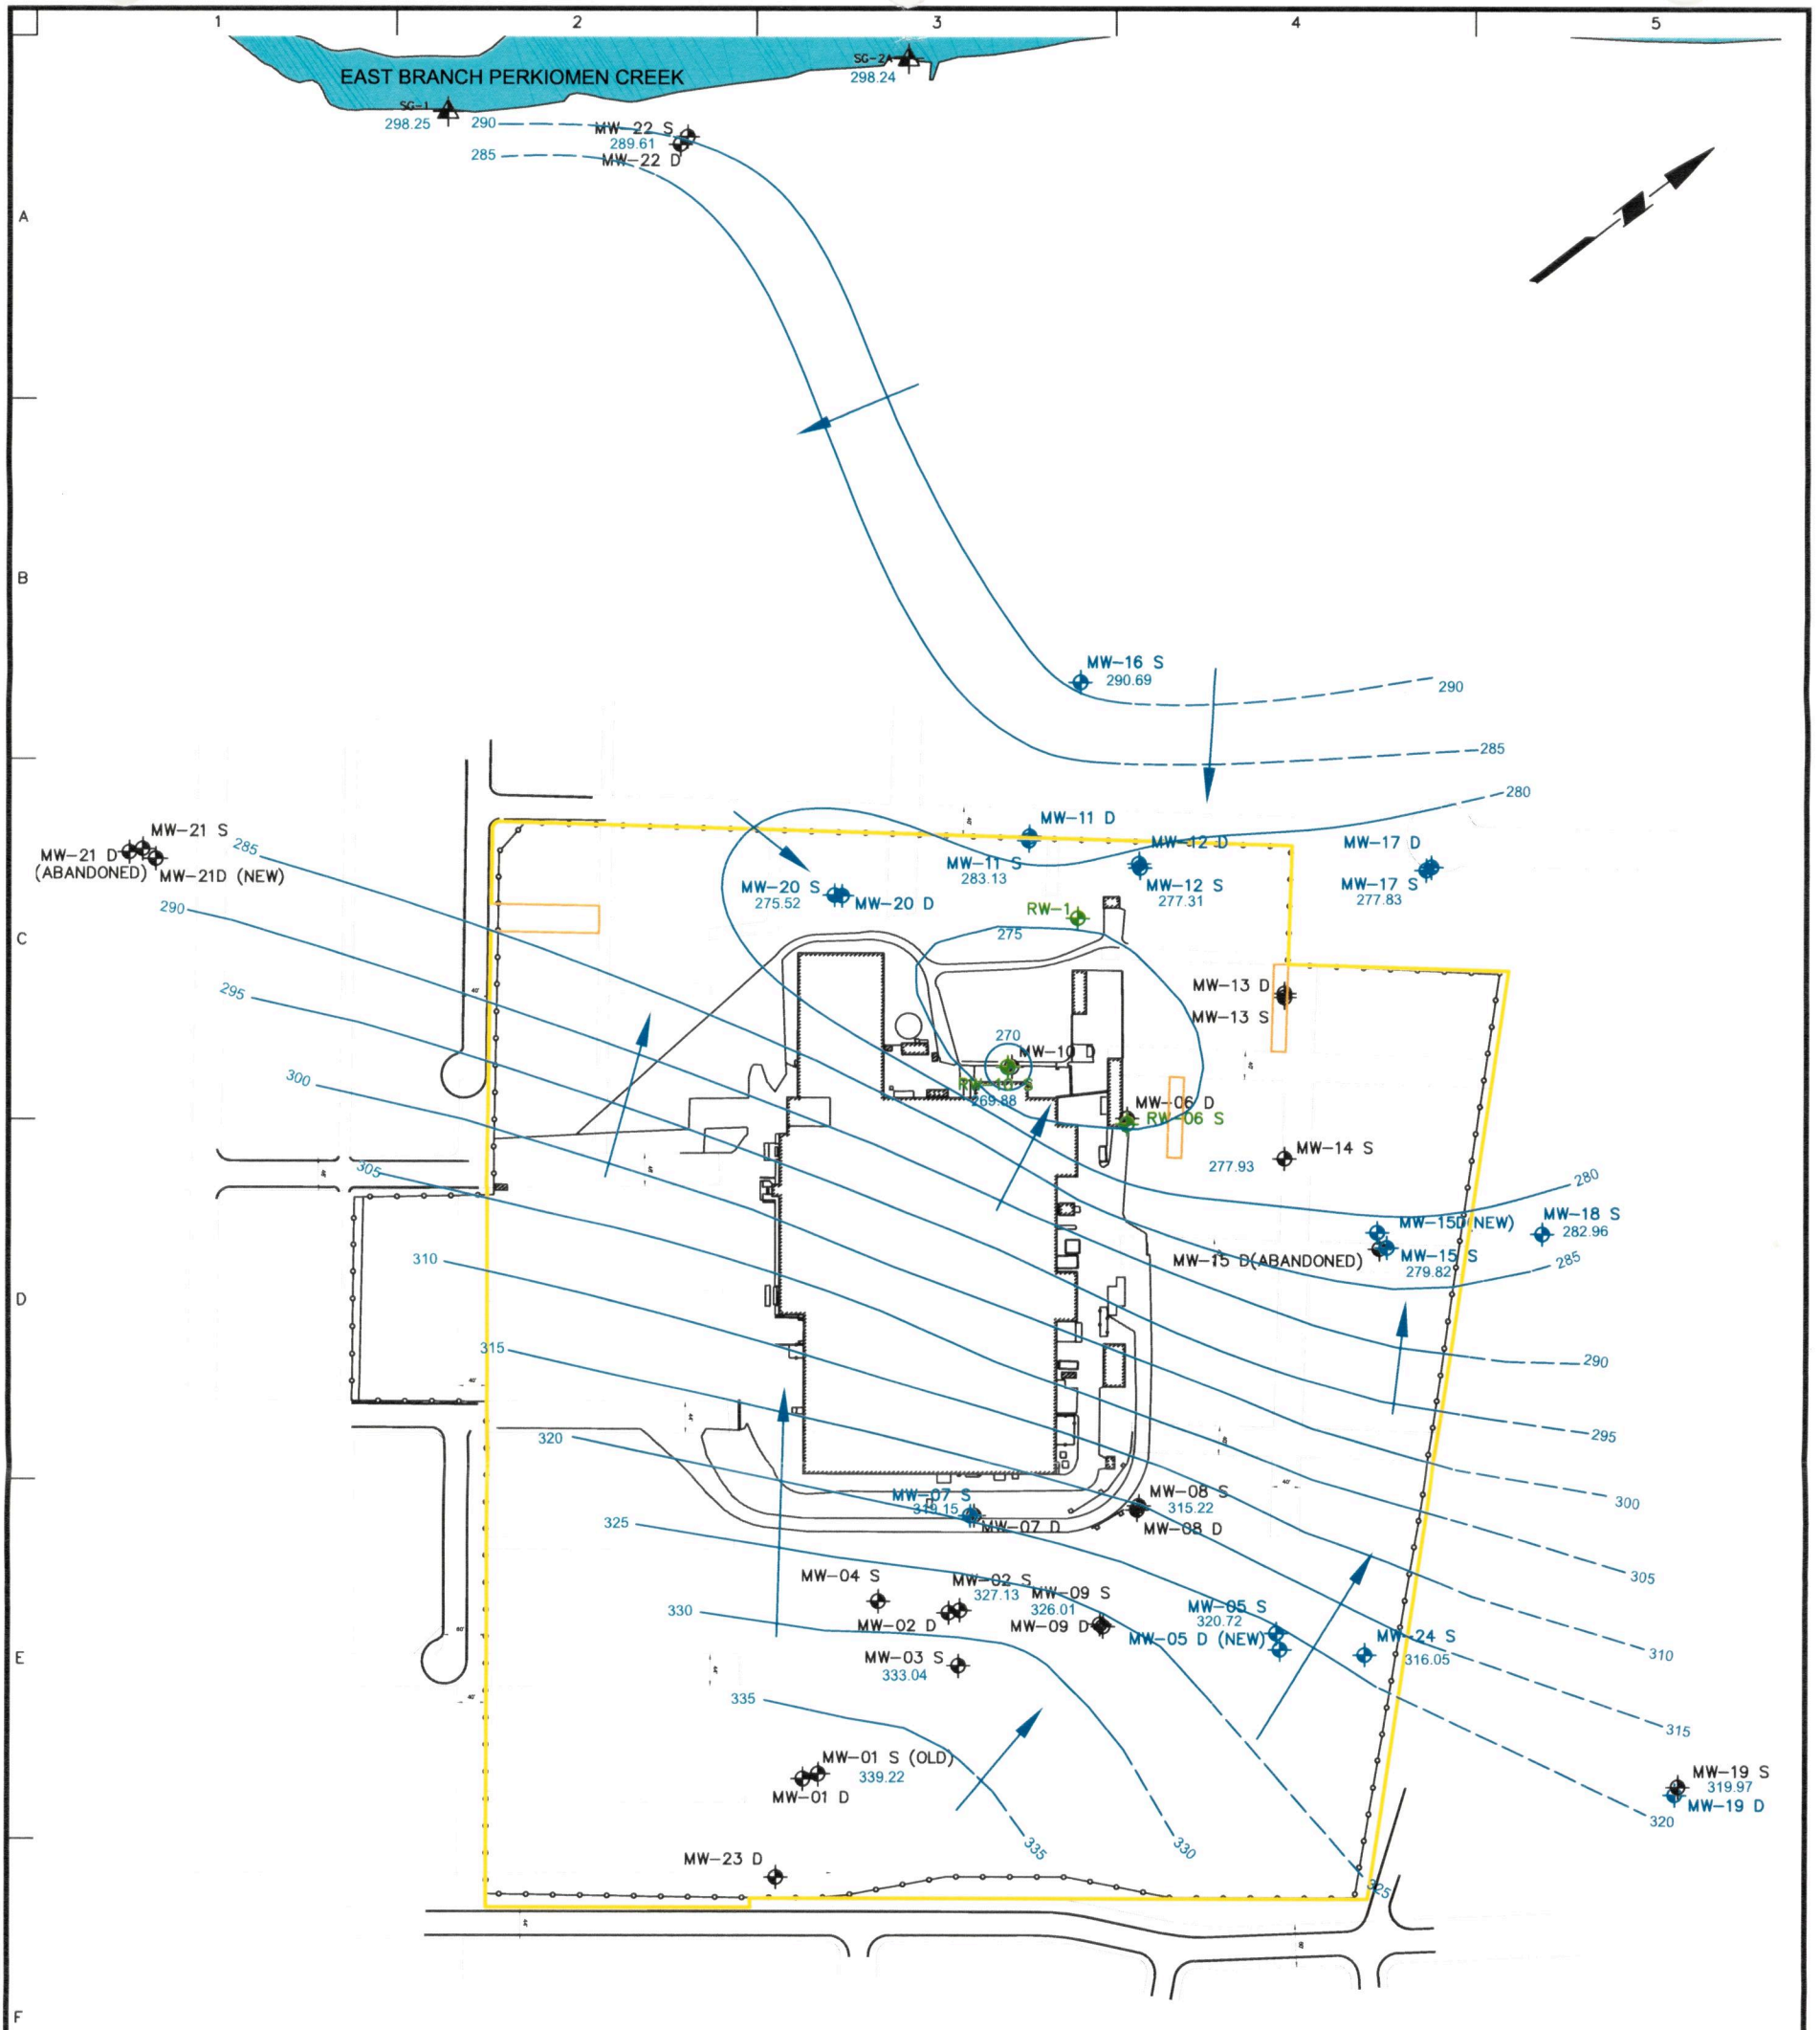
- NOTES:**
- 1) NEW SITE WIDE BASEMAP SURVEY WAS SURVEYED BY TAYLOR WISEMAN & TAYLOR ON NOVEMBER 2011.
 - 2) SOME MODIFICATIONS HAVE BEEN MADE TO THE GROUNDWATER MODELING SYSTEM VERSION 5.0 OUTPUT (CONTOURS) BASED ON SITE GEOLOGY AND KNOWLEDGE OF SITE CONDITIONS.

- 3) RW-1, MW-6S, & MW-10S ARE ACTIVE IRM SYSTEM GROUNDWATER RECOVERY WELLS.
 - 4) MW-1S(NEW), MW-5D, AND MW-14D WERE ABANDONED AND REPLACEMENT WELL MW-5D(NEW) WAS INSTALLED, APRIL 2005 AS RECOMMENDED IN THE FINAL LETTER REPORT ON THE ADDITIONAL ENVIRONMENTAL INVESTIGATION ACTIVITIES CONDUCTED IN JULY 2004.

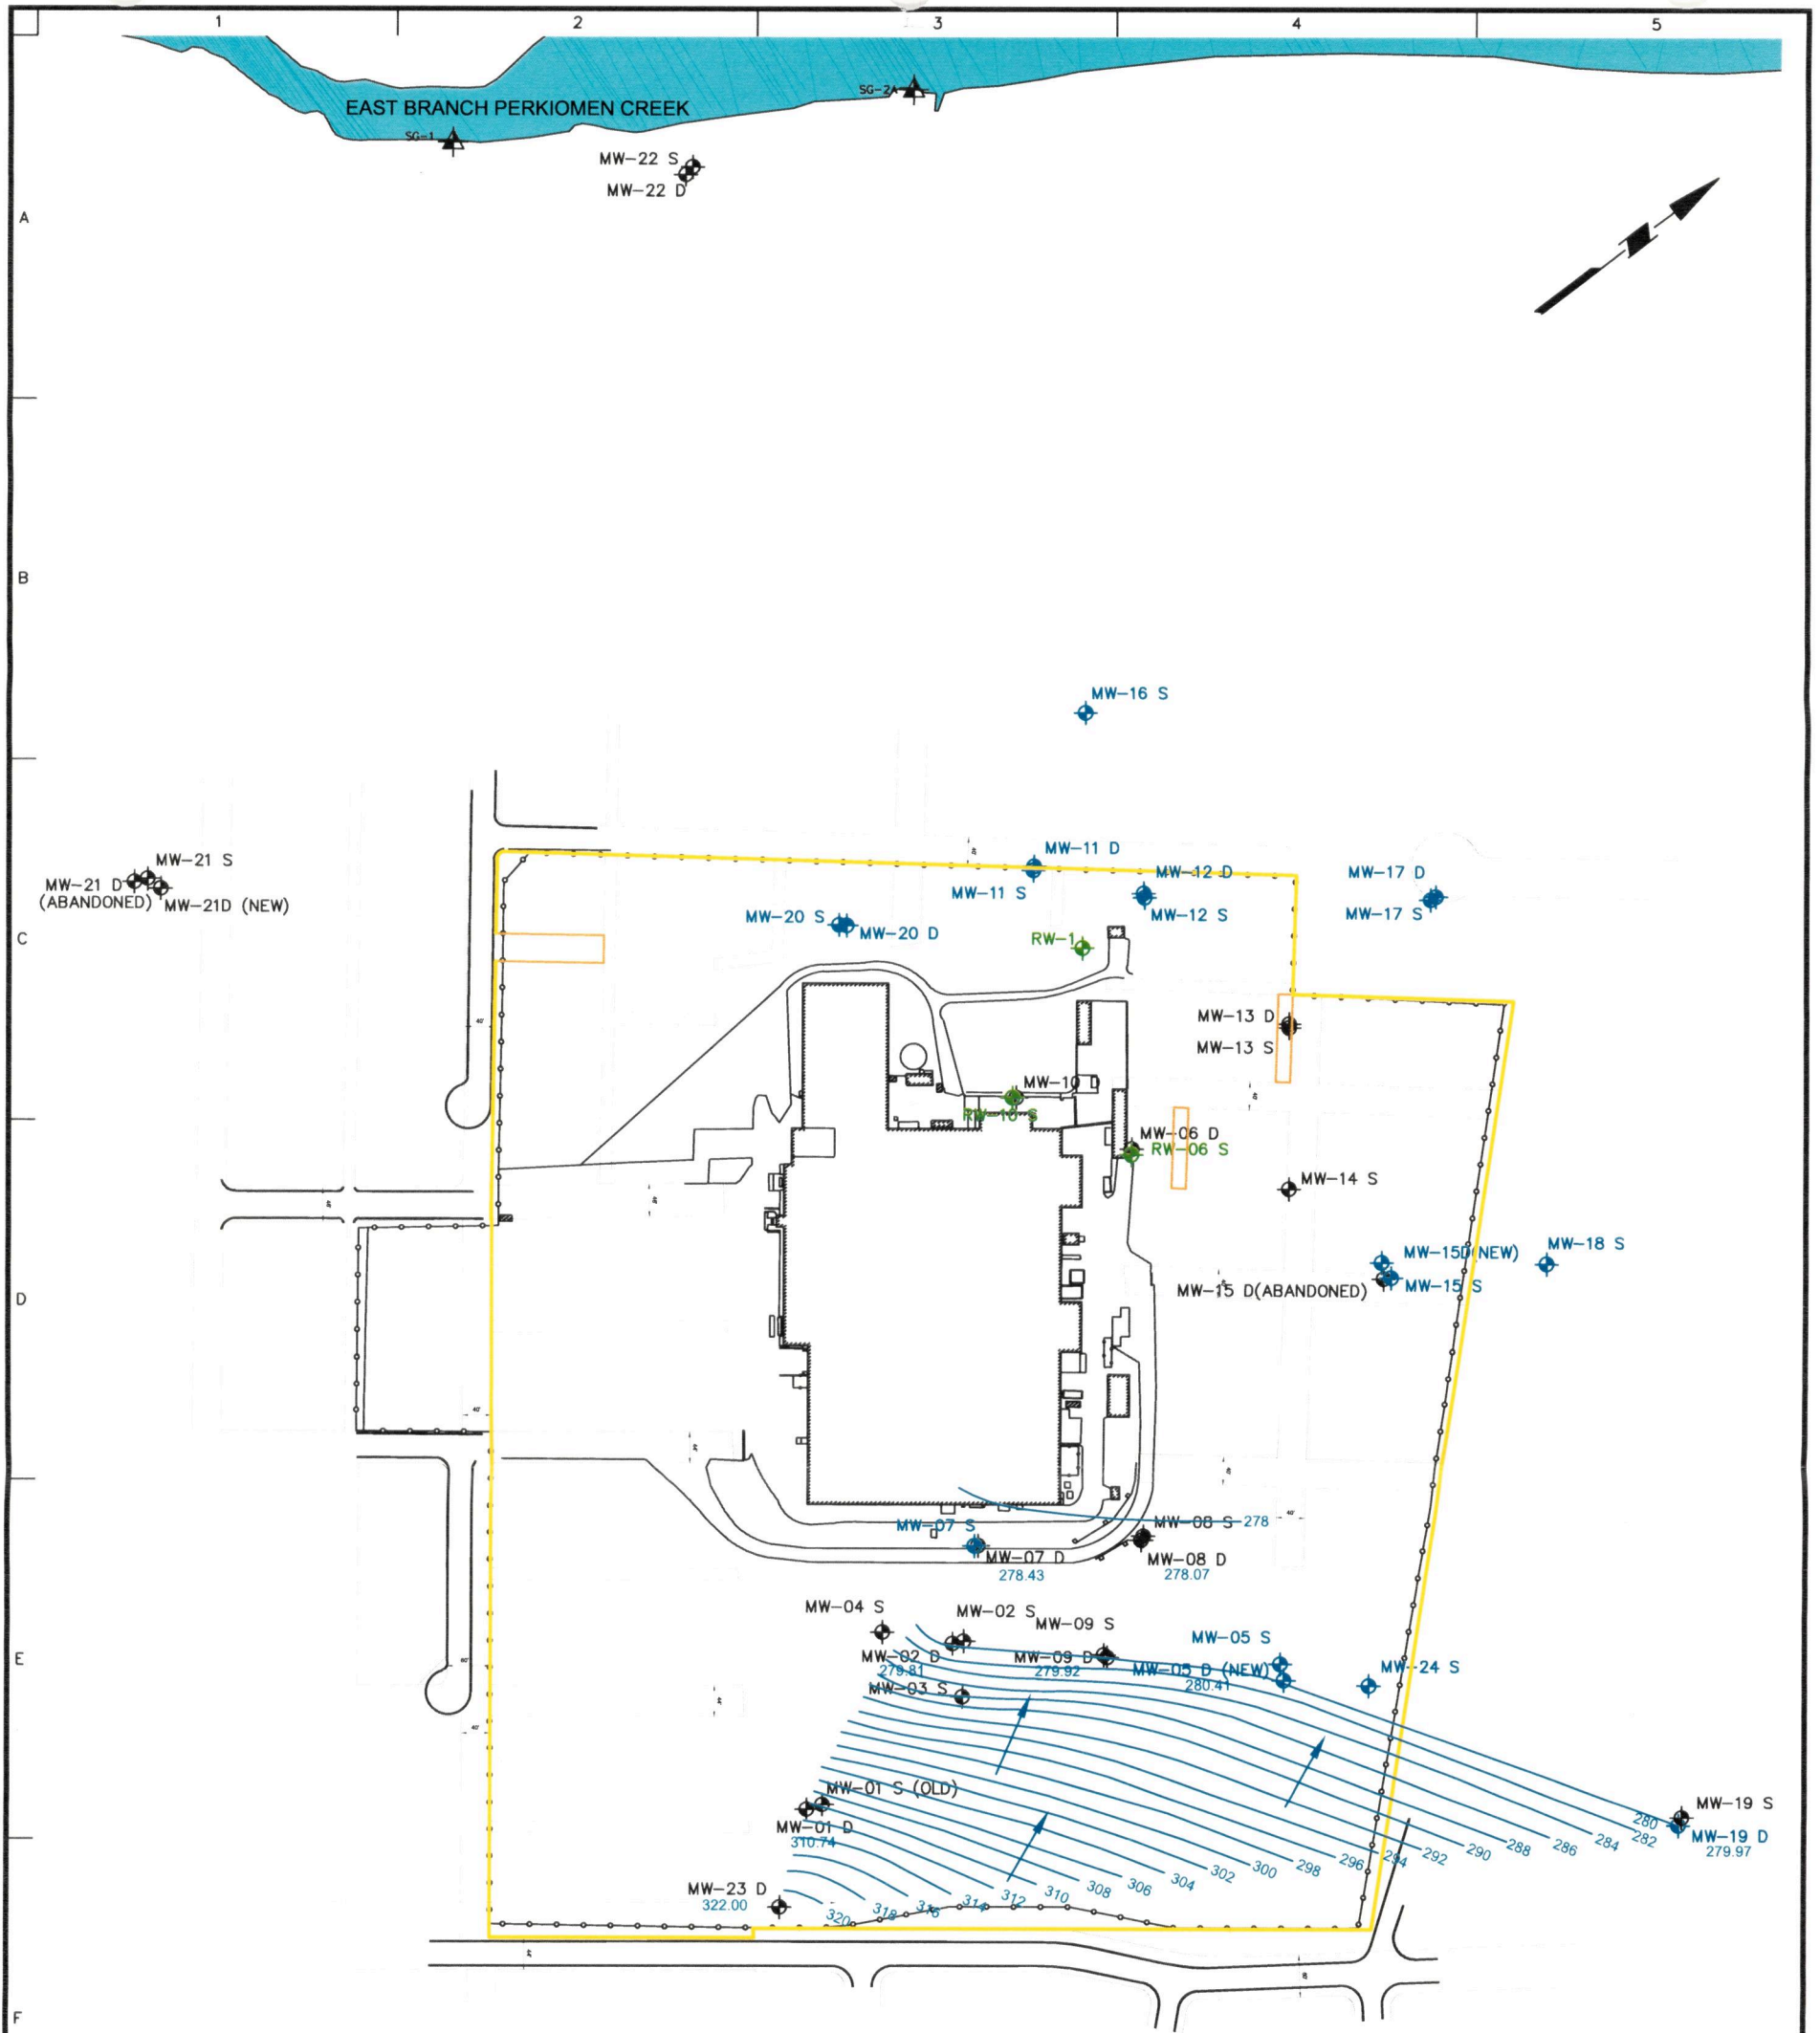
2) SOME MODIFICATIONS HAVE BEEN MADE TO THE GROUNDWATER MODELING SYSTEM VERSION 5.0 OUTPUT (CONTOURS) BASED ON SITE GEOLOGY AND KNOWLEDGE OF SITE CONDITIONS.

3) RW-1, MW-6S, & MW-10S ARE ACTIVE IRM SYSTEM GROUNDWATER RECOVERY WELLS.
